Evaluation of Zn-rich Primers and Rust Converters for Corrosion Protection of Steel

Leonardo Caseres

Southwest Research Institute

13. SUPPLEMENTARY NOTES 2009 U.S. Army Corrosion Summit, 3-5 Feb, Clearwater Beach, FL					
14. ABSTRACT					
15. SUBJECT TERMS					
16. SECURITY CLASSIFICATION OF:			17. LIMITATION OF ABSTRACT Same as Report (SAR)	18. NUMBER OF PAGES 22	19a. NAME OF RESPONSIBLE PERSON

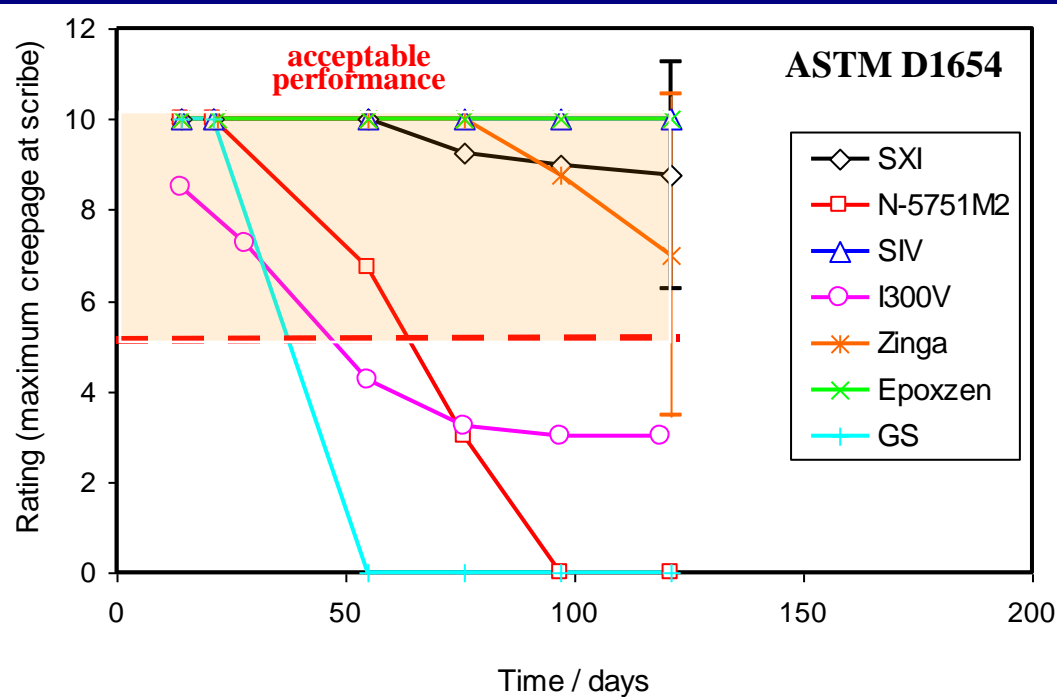
Results – Atmospheric Exposure: ZRC only

According to TACOM rating system

Stage 0: none

Stage 1: SIV, SXI, and Epoxzen

Stage 2: Zinga and I300V

Stage 3: N-5751M2 and Galvanized steel

The prevalent failure mode for most of the panels was blistering.

- SIV, Epoxzen, and SXI have acceptable corrosion ratings (>5.0) per ASTM D1654 (no blisters, minor red rust formation at the scribe and white rust elsewhere).
- The remaining coatings showed corrosion ratings <5.0 with medium-dense blisters and extensive formation of red rust over the entire surface.

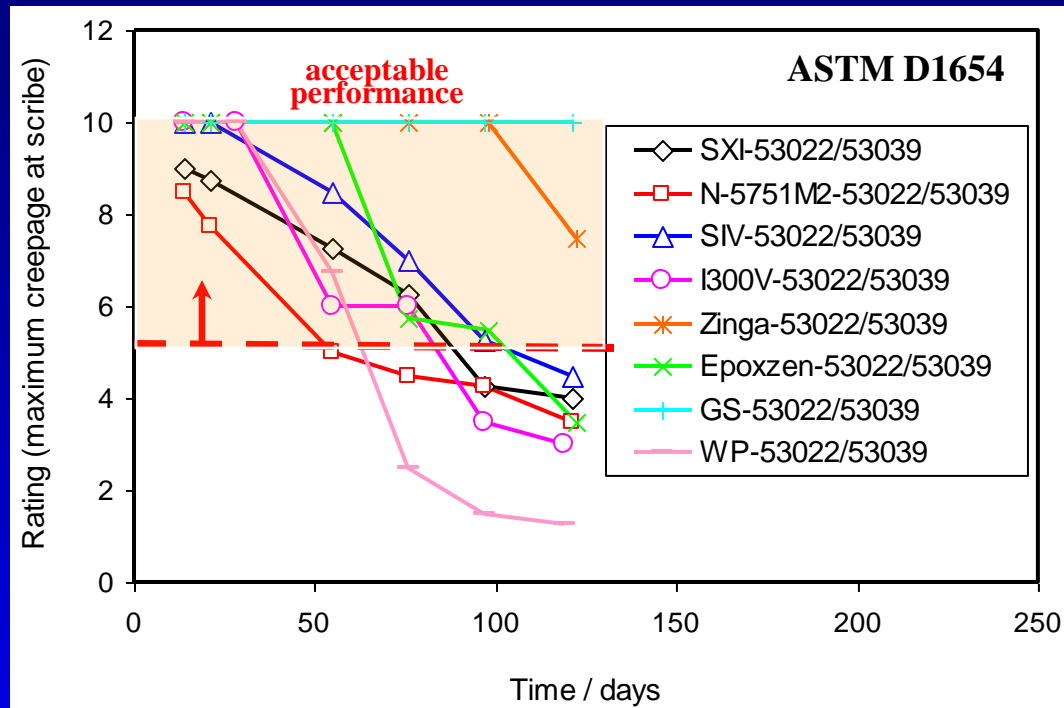
Results – Atmospheric Exposure ZRC-52022/53039II

SXI	0.8
N-5751M2	0.6
SIV	0.6
I300V	0.8
Zinga	2.9
Epoxzen	1.3
GS	0
WP	0.5

- Acceptable ratings (5.0) were noted for galvanized steel and Zinga coating. Corrosion localized at the scribe with nearly intact coating elsewhere.
- The remaining coatings showed ratings <5.0 with red rust corrosion at the scribe, edges and medium-dense blisters surrounding the scribe.

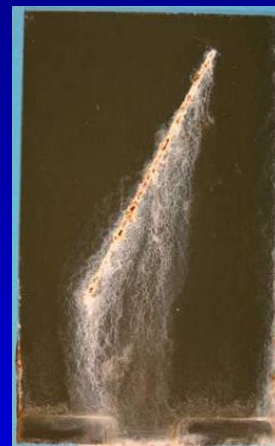
Galvanized steel
(stage 1)

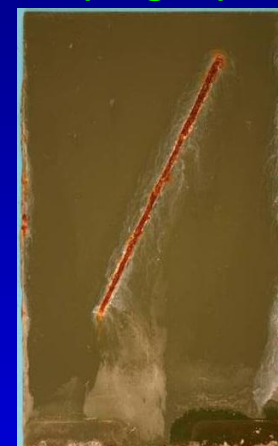
Zinga
(stage 1)

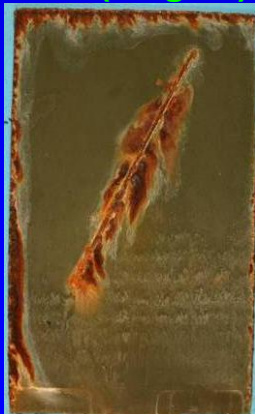
SIV (stage 2)

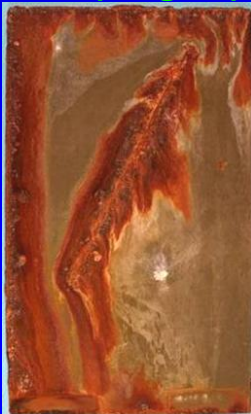
SXI (stage 2)

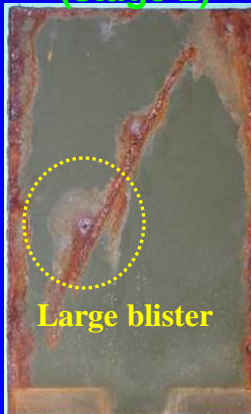
Wash Primer
(stage 2)

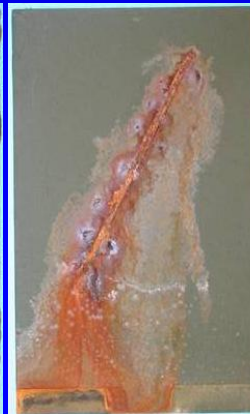
I300V (stage 2)

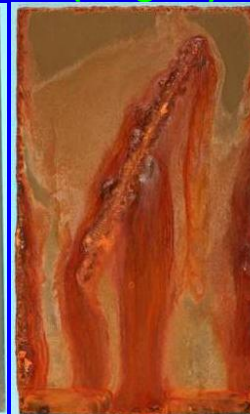
N-5751M2
(stage 2)

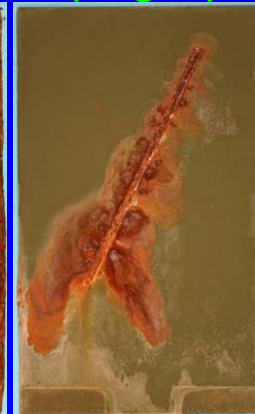
Epoxzen
(stage 2)

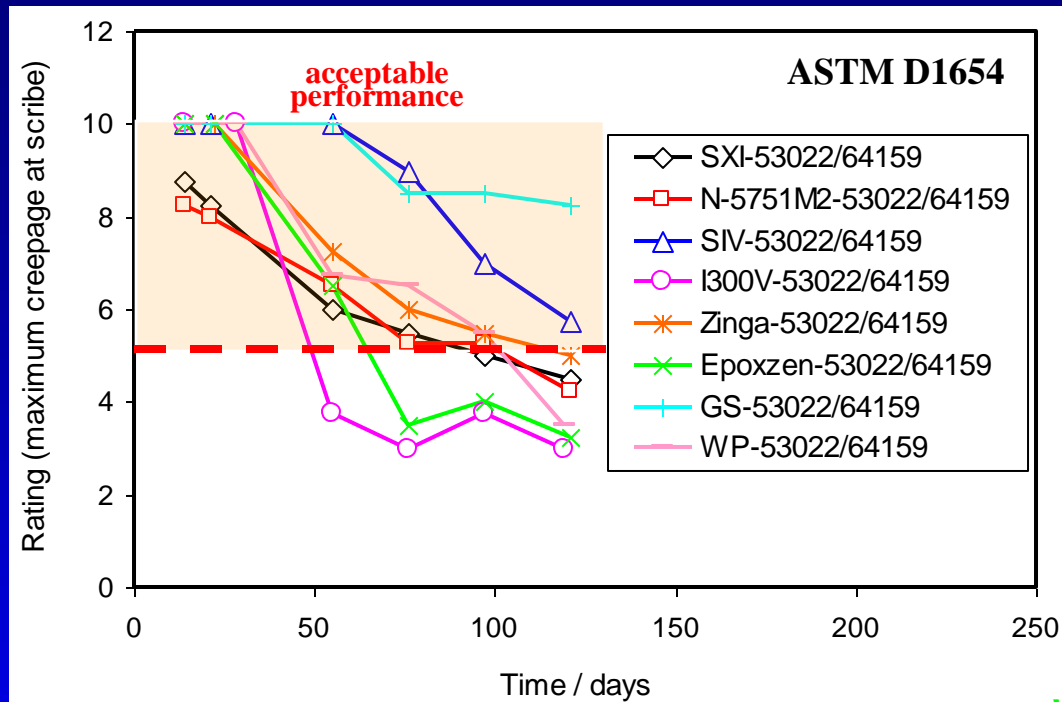
Results – Atmospheric Exposure ZRC-52022/64159II

SXI	0.6
N-5751M2	0.5
SIV	0.5
I300V	0.8
Zinga	0
Epoxzen	0.5
GS	2.1
WP	1.7

- Acceptable ratings (>5.0) were noted for galvanized steel, SIV, and Zinga coatings.
- The remaining coatings showed ratings <5.0 with red rust corrosion at the scribe, edges and medium-dense blisters surrounding the scribe.

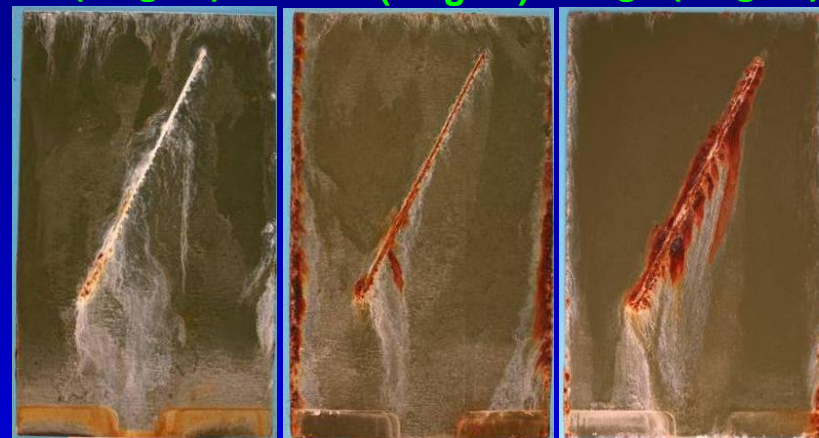
GM 9540P – Top Rated Coatings

Galvanized steel
(stage 1)

SIV (stage 1)

Zinga (stage 1)

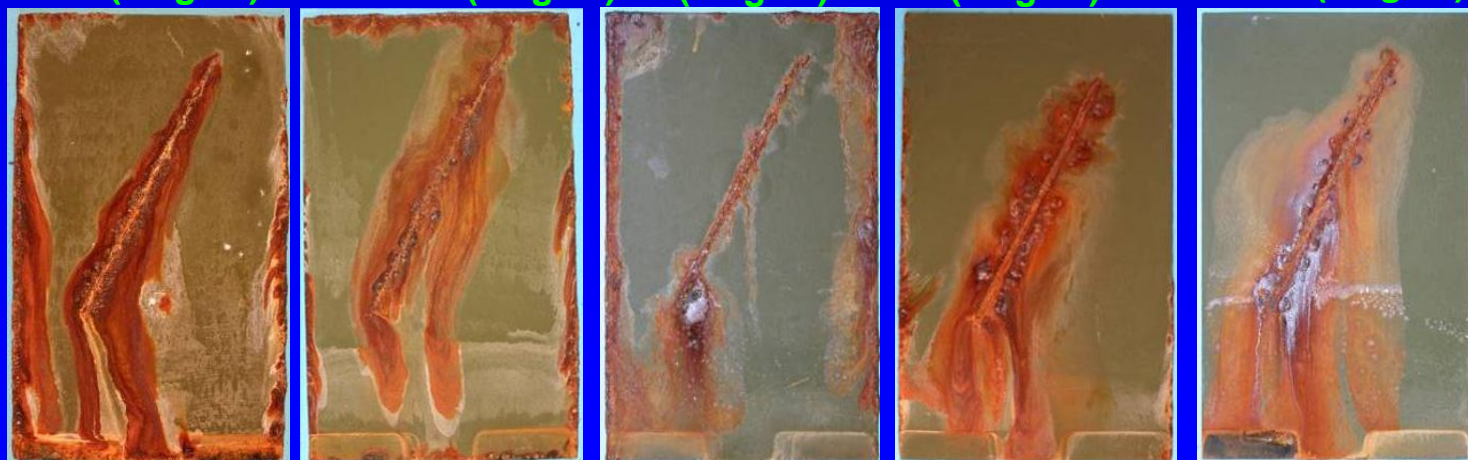
GM 9540P – Low Rated Coatings

Wash Primer
(stage 2)

Epoxzen
(stage 2)

I300V (stage 2)

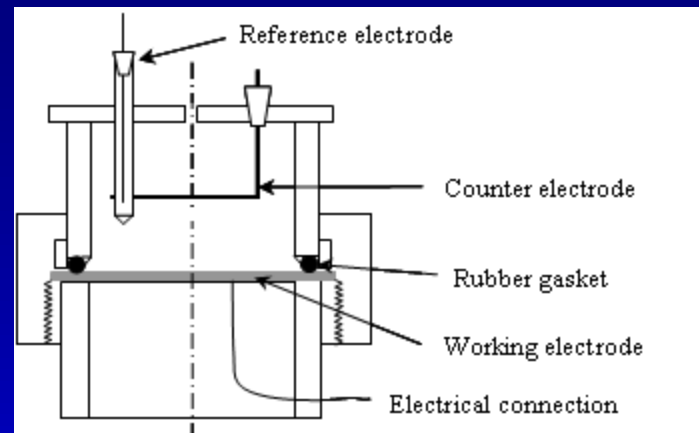
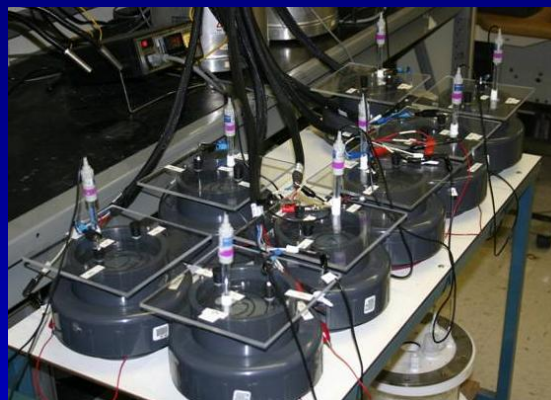
Test Cell Arrangements

Specimen area: 95 cm²
 Scribe size: 3 cm by 0.2 cm
 Naturally aerated system
 Exposure time: 80 days
 Simulated seawater
 Solution volume: 500 cm³
 Solution temperature: 21-24°C

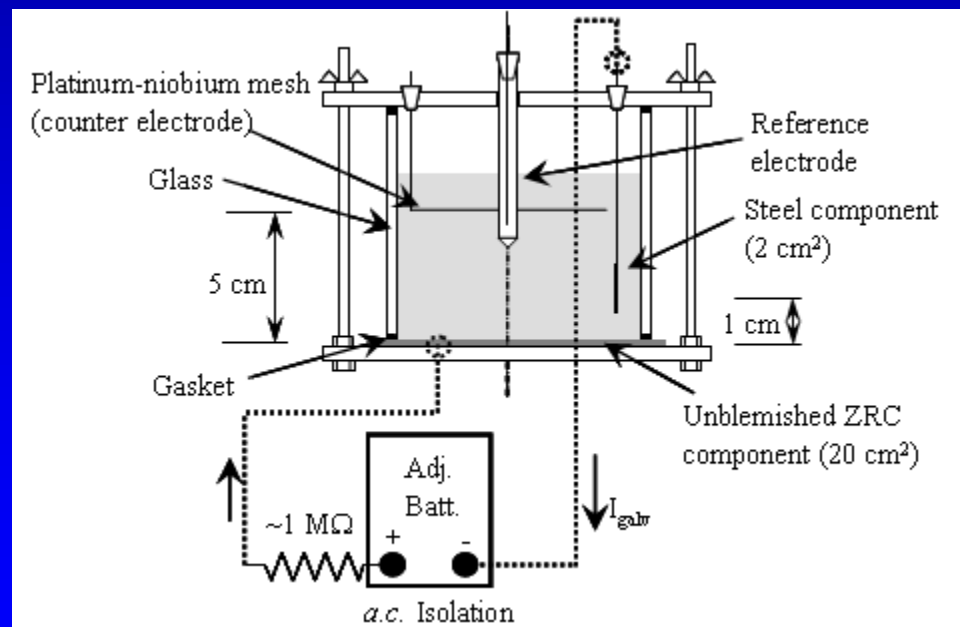
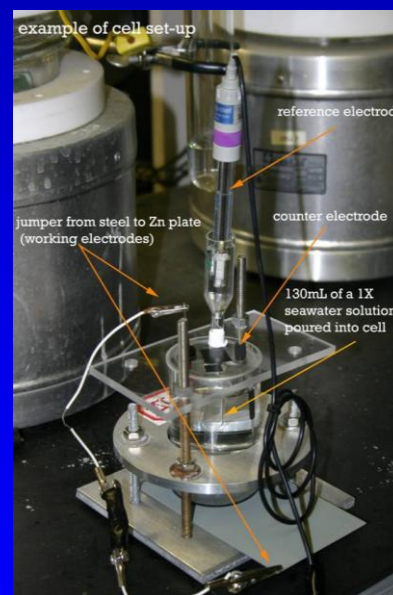
EIS and galvanic corrosion cell

Naturally aerated system
 Exposure time: 75 days
 Simulated seawater
 Solution volume: 120 cm³
 Solution temperature: 21-24°C

- Steel component: 320-grit surface finish, back side covered.
- ZRC/bare steel always connected except during EIS tests.
- Current sign: positive when ZRC is the anode

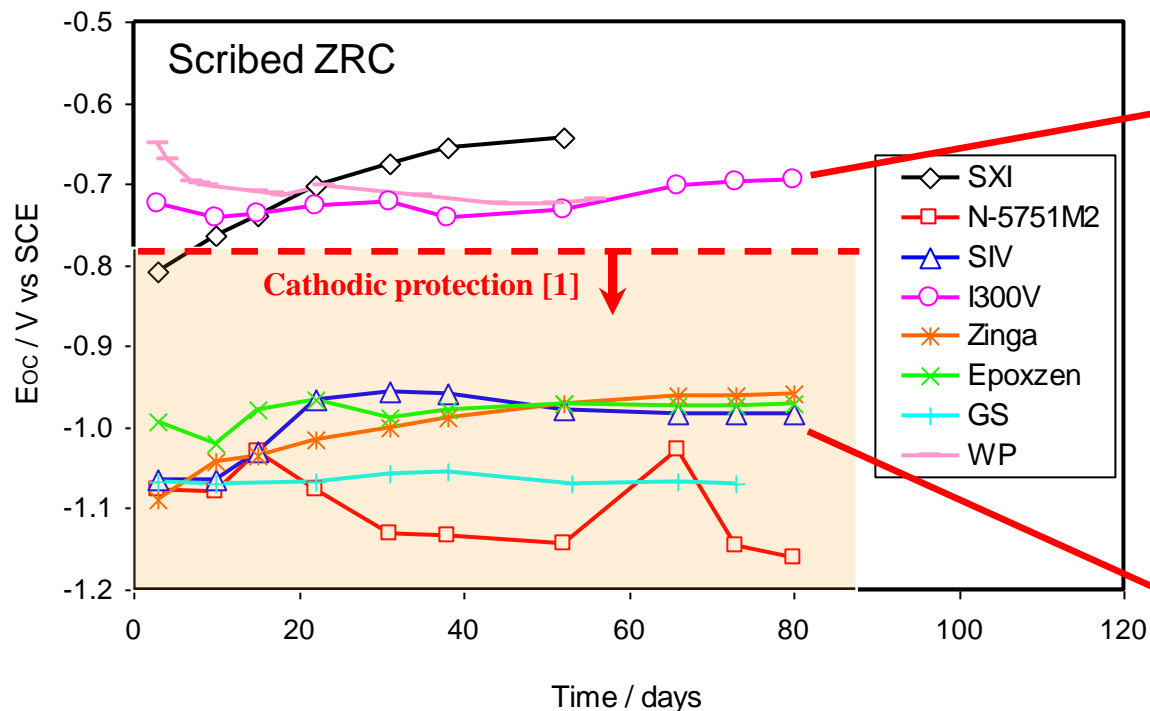
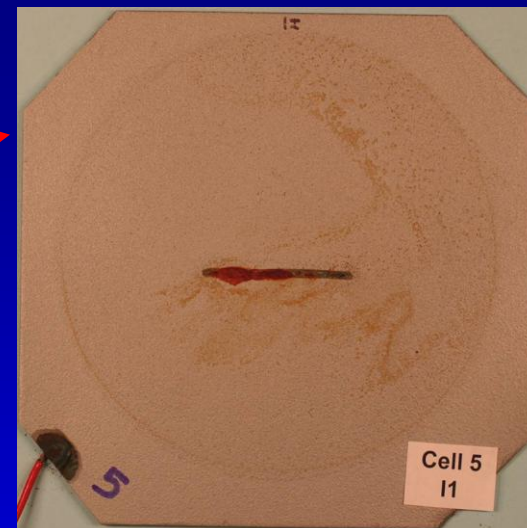
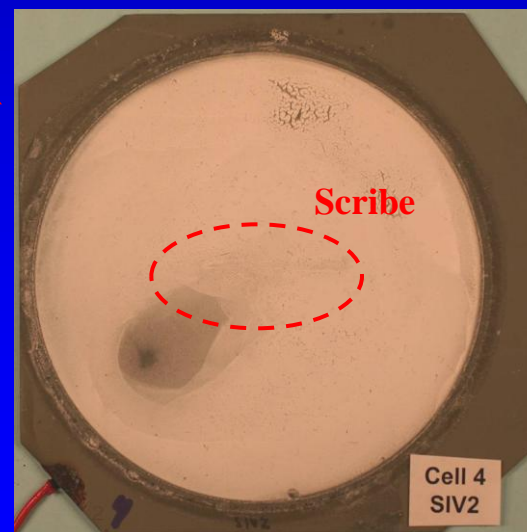
Results – Immersion Tests Open Circuit Potentials

- E_{OC} of sacrificial coatings $\sim E_{OC}$ of plain steel would not yield sufficient galvanic protection.
- Scribed I300V and WP panels had red rust at the scribe and no corrosion elsewhere.
- The other ZRC panels showed no red rust at the scribe consistent with E_{OC} trends.

- $E_{OC} \sim -700/-750$ mV for I300V, WP, and SXI scribed panels, indicative of limited sacrificial ability by the coating (formation of red rust at the scribe) and $E_{OC} \sim -1$ V for the remaining scribed panels (steel surface remained free of corrosion and the ZRC showed signs of active corrosion).

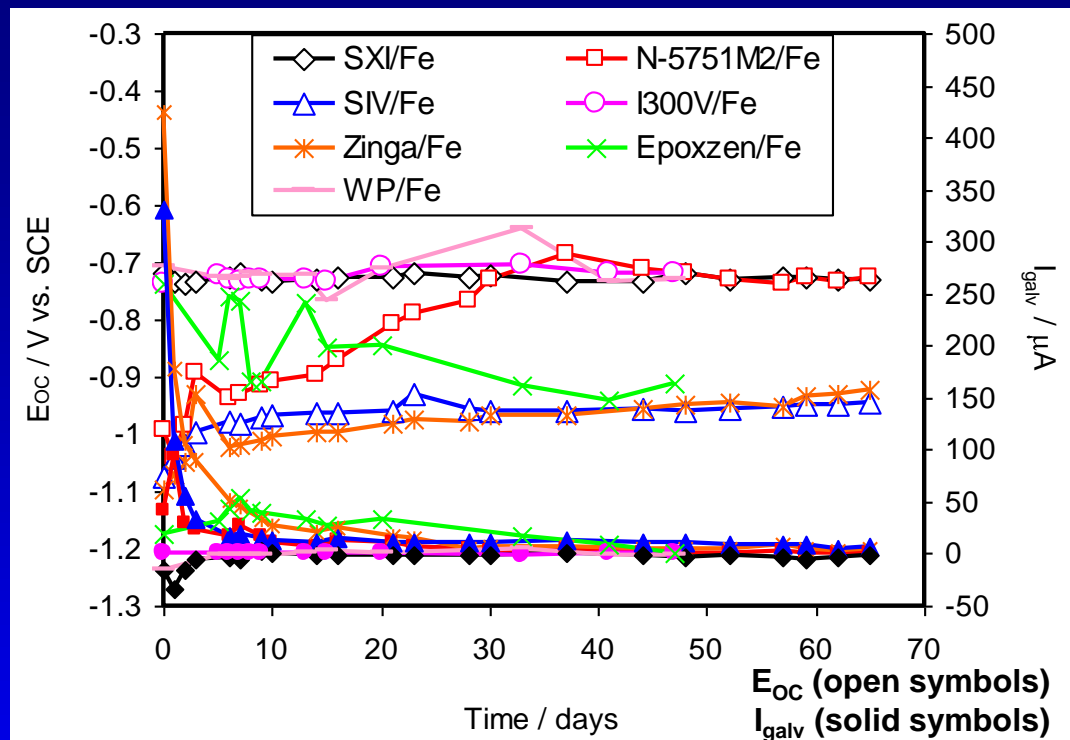
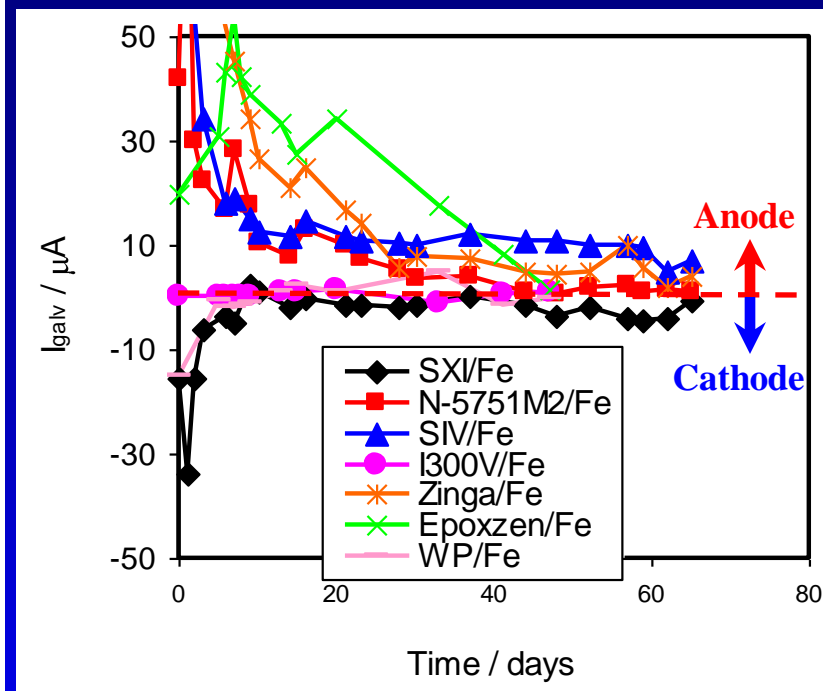
Results – Immersion Tests Galvanic Current Measurements

- The steel was always net cathodes except for the SXI, I300V. and WP, which showed transient anodic-cathodic behavior.
- The ZRC surface showed white discoloration except for the I300V and WP coatings.
- The steel components showed red rust formation, inconsequential for the case of the Zinga/Fe and SIV/Fe assemblies, and more prominent for the other assemblies. The appearance of red rust in the N-5751M2/Fe, WP/Fe, I300V/Fe, and SXI/Fe assemblies were in agreement with positive E_{oc} excursions, indicative of limited cathodic protection by the ZRC.

- Galvanic currents were anodic for the N-5751M2, SIV, Epoxzen, and Zinga ZRC. Only the galvanic currents delivered by the SIV and Zinga ZRC were enough to prevent steel rust formation. The SXI, I300V, and WP ZRC showed transient anodic-cathodic behavior (extensive steel rusting).

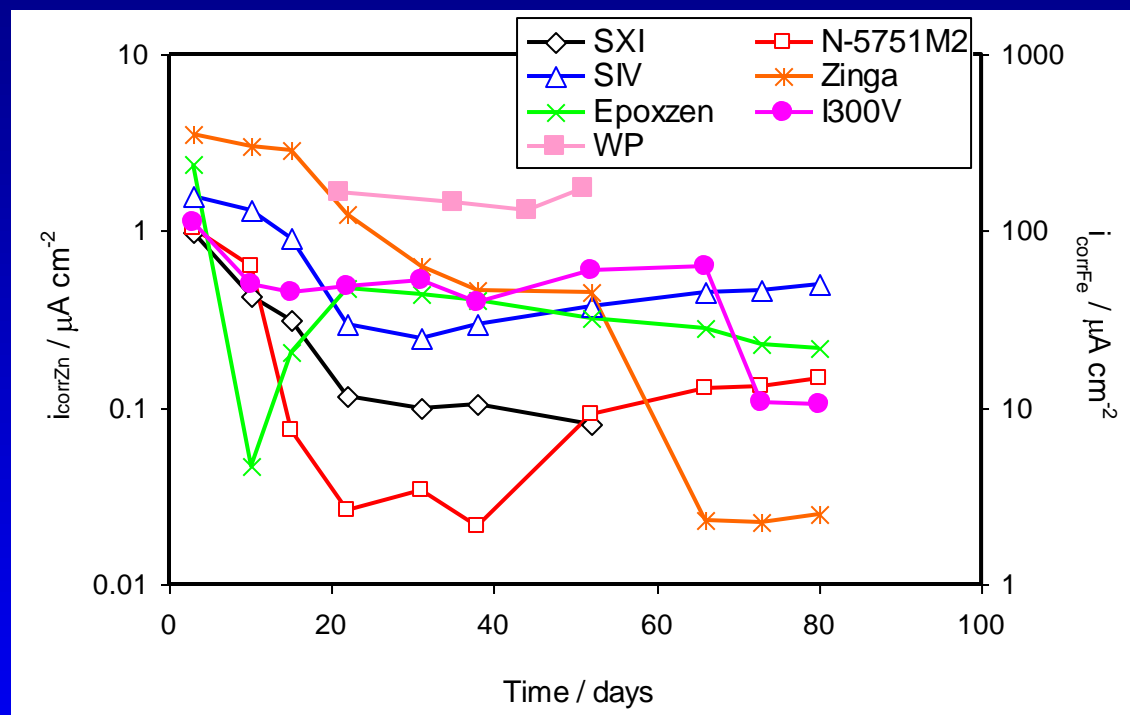
Corrosion Rates

i_{corrFe} (solid symbols) and i_{corrZn} (open symbols) for the scribed ZRC panels

- I300V and WP showed initially large corrosion rates of the exposed steel, consistent with observation of corrosion deposits at the scribe. Corrosion rates for the ZRC were low ($<1 \mu\text{A/cm}^2$) by the end of exposure, except for the I300V and WP (coating in passive state with extremely low corrosion rates).

- Corrosion rates of the exposed steel at the scribe for the I300V and WP panels were initially large ($>120 \mu\text{A}/\text{cm}^2$) in keeping with the formation of corrosion products over the steel. The corrosion rates of the steel for the remaining scribed ZRC panels were expected to be negligible due to the steel cathodic polarization to potential levels where the Fe/Fe^{+2} reaction is near equilibrium at the low Fe^{+2} ion concentration levels of the solutions.

- Corrosion rates of the ZRC surrounding the scribe ranged from $0.05 \mu\text{A}/\text{cm}^2$ (Zinga) to $0.5 \mu\text{A}/\text{cm}^2$ (SIV). The I300V and WP coating in the scribed panels did not show signs of corrosion distress, suggesting that the coating acted solely as a physical barrier.

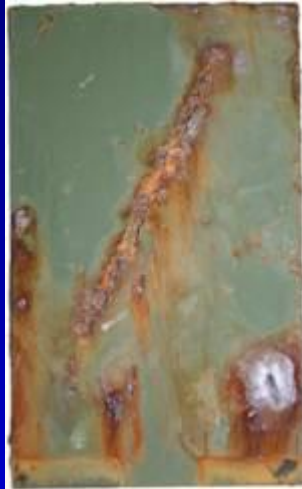
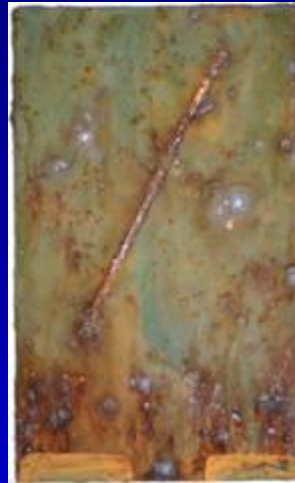
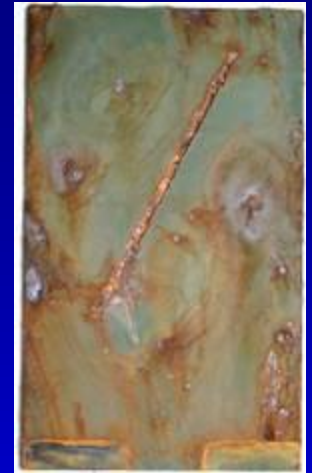
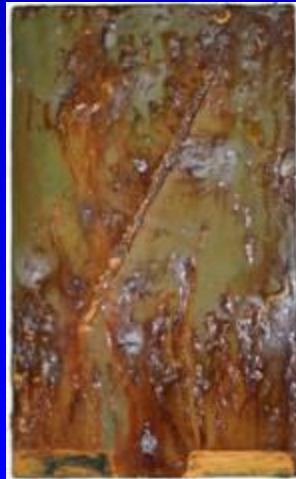
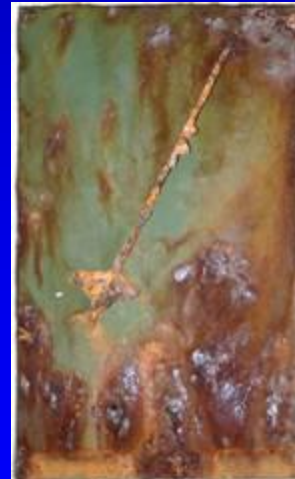
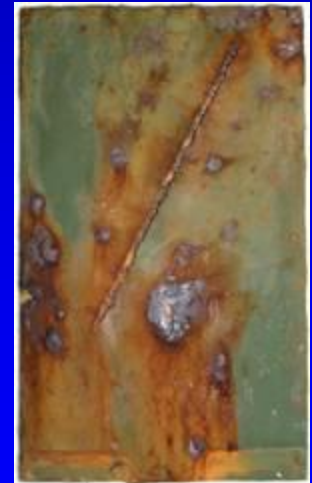
50-day exposure – scribed specimens

Major corrosion damage in all specimens.
Corrosion started at the scribe, and propagated under coating, causing blisters.
Paint delamination at the scribe.
Rust converters not appropriate for damaged coatings.

- Extended corrosion damage in all specimens.
- Corrosion started at the scribe, and propagated under coating, causing blisters.
- Paint delamination at the scribe.
- Rust converters appeared not to be appropriate for damaged coatings.

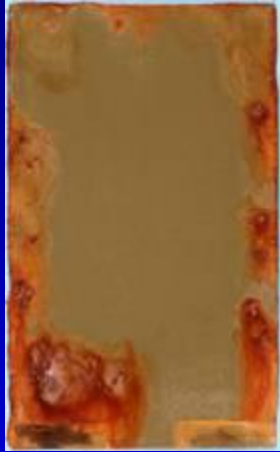
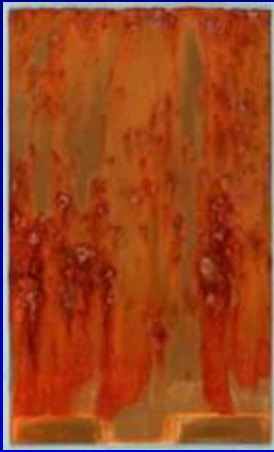
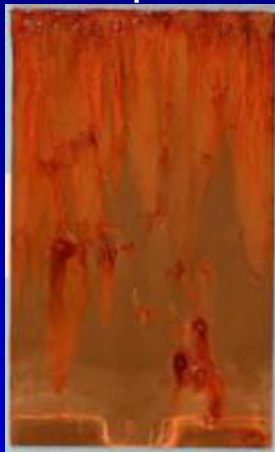
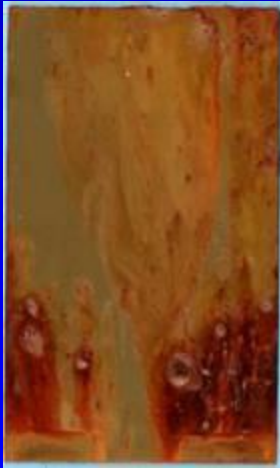
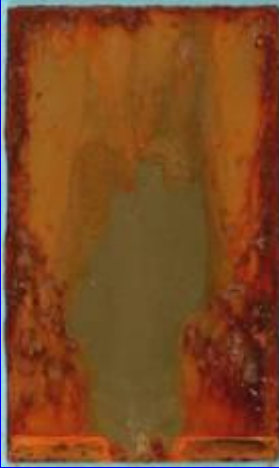
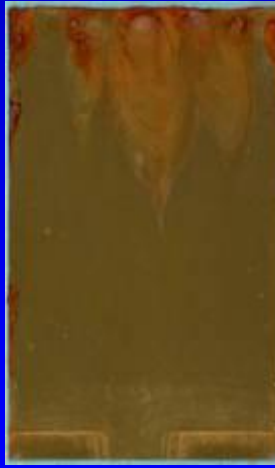
91-day exposure – unscribed specimens

Blister and pinholes in all specimens.
Best performer: Total Solutions (water-based, tannic acid).

- Blisters and pinholes in all specimens.
- Best performer: Total Solutions.
